July 9, 2015

Subject: Red and Bonita Mine, Silverton, CO
Site Visit Summary and Ground Control Plan

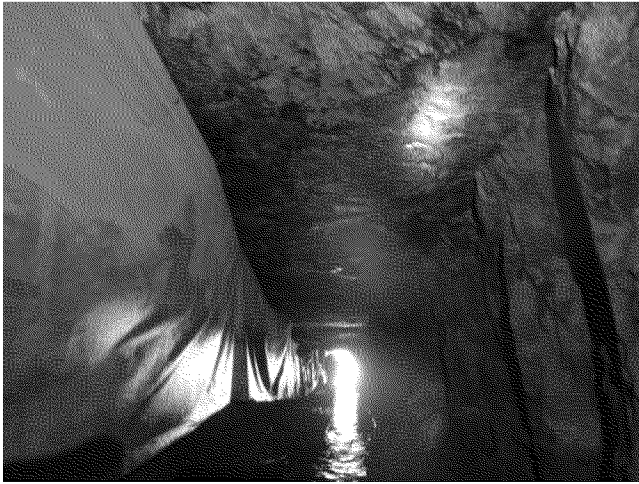
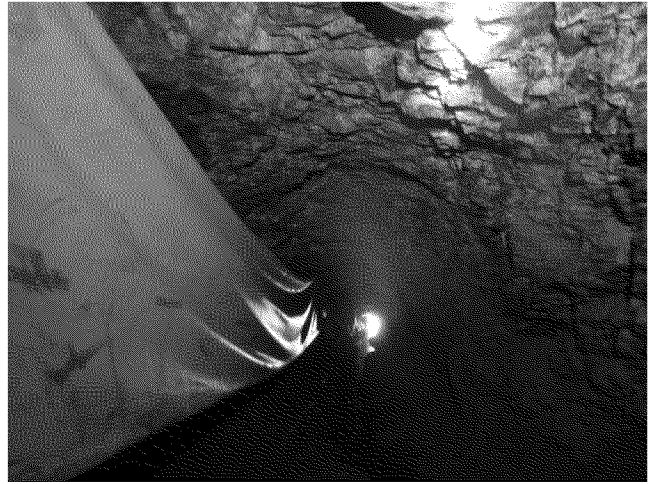
Per the geologic map, there is considerable variation in the local orientations of the fissures, faults, and veins in the vicinity of the Red and Bonita Mine and this was apparent within the tunnel with various sections of the tunnel demonstrating prominent jointing and others exhibiting random jointing. Due to the considerable variation in jointing, no discontinuity measurements were taken during the site visit.

Photos 1 & 2: Contrast in Rock Jointing and Tunnel Section
(Well defined jointing and rectangular profile (left) vs. numerous random jointing and rounded profile (right))

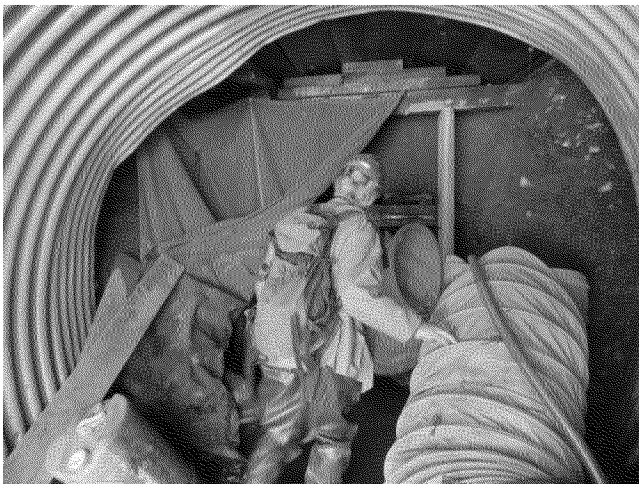
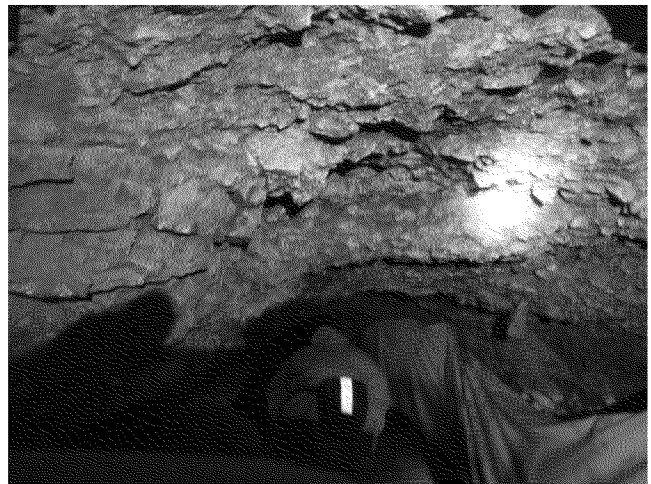
The portal area has been supported by a corrugated metal pipe, overhead timber lagging, and dual timber square sets (one large and one small) within the past few years. Inby from the portal, the rock consists of a breccia, basically a conglomerate comprised of angular rock fragments in a cemented matrix, for the first 40 to 60 feet. Although the matrix material appears to be weathered, limited probing and hammer impacts indicate that the breccia is well cemented. The majority of the rock surfaces were stained and no recent or visible rock falls were apparent in the breccia.

Photos 3 & 4: Initial Main Drift in Breccia near Portal

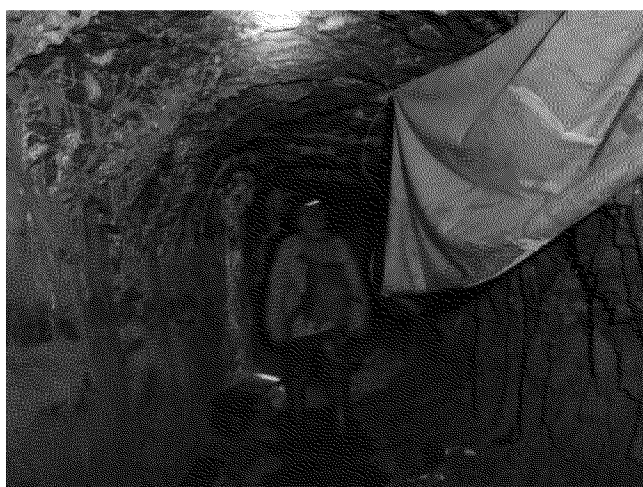
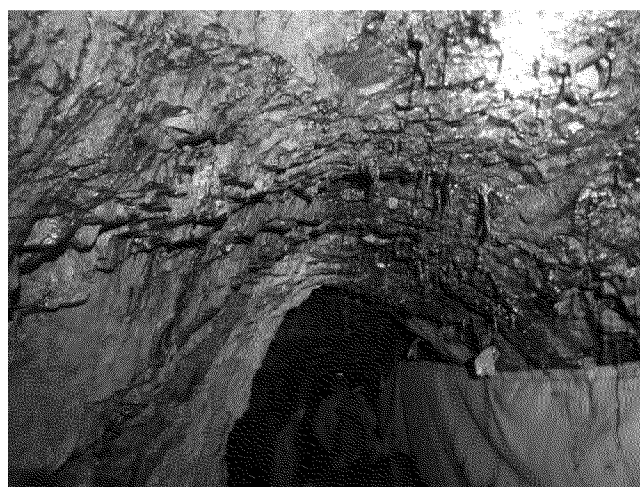
Beyond the breccia, the host rock switches to a relatively massive, homogenous volcanic rock (likely rhyodacite) with prominent vertical and near horizontal fracturing (refer to Photo 1). Further inby, the rock jointing varies significantly with other areas having frequent and randomly oriented joints without any apparent dominant joint sets (refer to Photo 2). The well-defined jointed areas and the “confused” jointed areas tend to alternate throughout the mine adits, as well as the frequency of jointing. Many of the joints appeared to be either tight or have some infilling and only infrequently were open fractures observed in the rock. While the 275-Drift was not entered during the site visit, a visual observation of the adit from the junction of the main drift indicated that rock conditions appeared similar to main drift and no stability issues were noted. For the main drift, there are several areas in the crown where the rock has been recently exposed; one of these was due to a surface boring penetrating the adit and several others were likely due to recent rock scaling operations for the DRMS inspections and vent line installation. Sporadic individual rock fragments (less than 3”) and small rock blocks (typical 3” thick by 12” square) showed some minor separation and it is recommended that a rock scaling program be implemented to reduce the rock fall hazards during construction. DRMS indicated that some of the rock blocks showing separation are still locked in place and will require significant effort to dislodge. Due to the infrequency of open fractures, only a minor amount of rock scaling will need to be performed. All of the unsupported adit areas visited appeared to be stable during the visit and would classify as “stable rock” per OSHA 1926.652 (a)(1)(i).

Photos 5 & 6: Typical Main Drift Rock Conditions

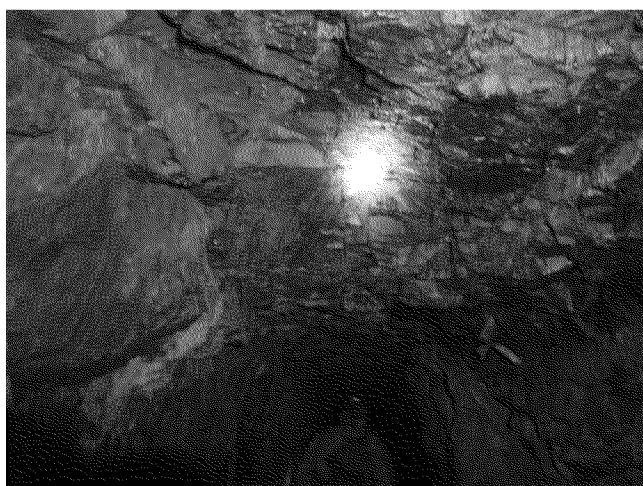
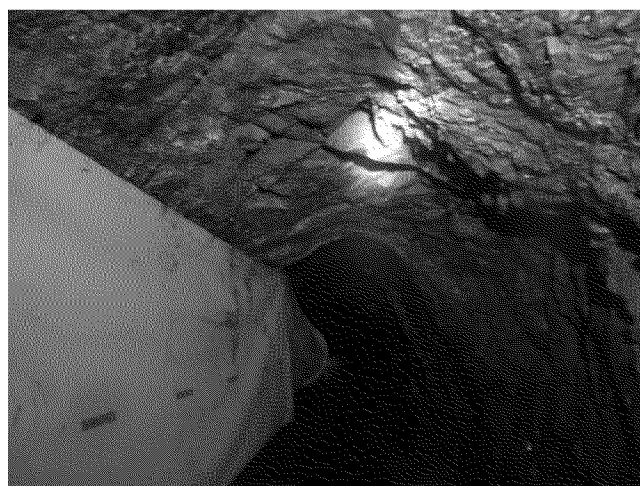
Photos 7 & 8: Typical Main Drift Rock Conditions

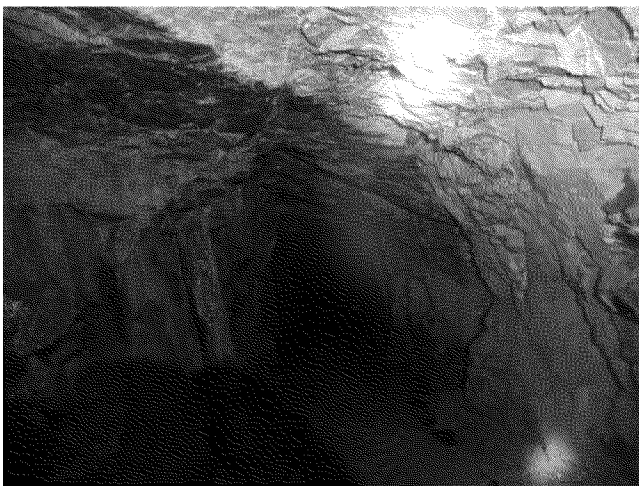
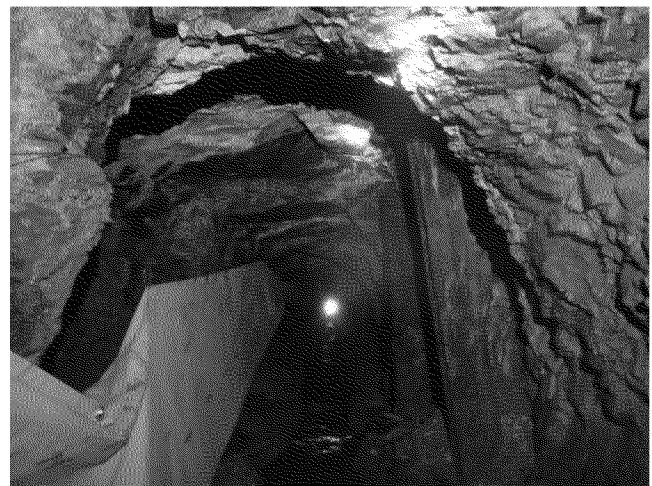
In addition to the recent timber support at the portal, there were three areas that showed evidence of timber support. The first area was at the junction of the 275-Drift with the main adit where several round vertical posts are located adjacent to the junction; only one of these posts was blocked to the overlying rock (275-Drift) with the others in the main drift simply remnants of prior support. No evidence/debris of prior extensive timber support (such as timber sets or lagging) was observed in the invert. There does appear to be fresh rock surface overlying the junction and it is unknown as to whether this area was recently scaled. Regardless, the current rock conditions appeared to be stable and competent and do not appear to require supplemental support.

Photos 9 & 10: Junction of 275-Drift with Main Drift (Looking down 275-Drift with blocked timber post (left) and main drift looking outby with overhead fresh rock exposure and remnant posts (right))

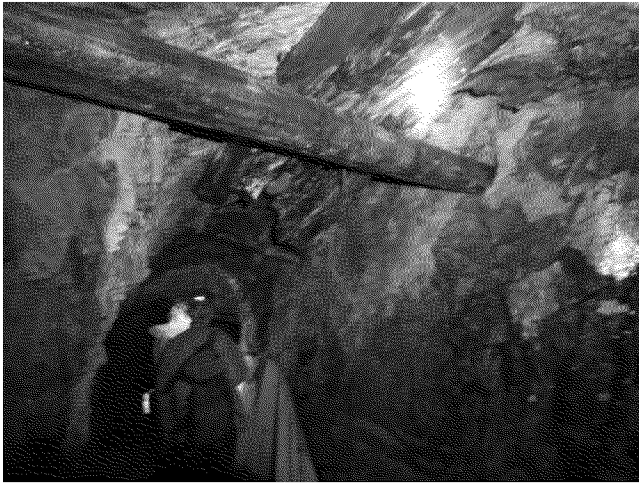
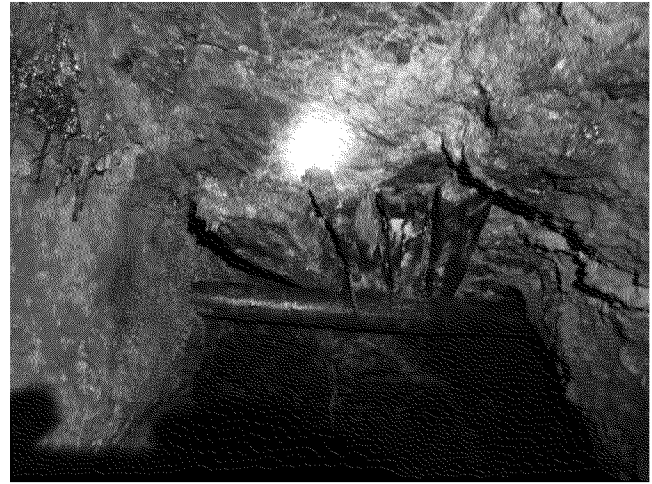
At the junction of the Main Drift with the Northern Heading, a single round timber stull is located in the crown and supports several lagging boards while a second unloaded/unlagged timber stull is located inby. Limited probing of the stull and lagging with a geologist hammer indicates that the point is readily able to penetrate the outer 1/8" to 1/4" into the timber before relatively solid timber is reached. The timber support system appeared intact and no obvious signs of either distress or decay were observed. There appears to be less than 6" of rock debris loading the lagging and thus, for the heavy timber stull and lagging, the timber system is very lightly loaded. Based on the unsupported and exposed rock conditions surrounding the timber lagged area, consideration could be given to removing the timber supports and scaling the crown, however this presents some inherent rockfall risk and it is believed that leaving the timber in place and undisturbed is the best alternative given the current stability of the timber support and limited amount of construction access that is needed beyond the bulkhead and cofferdam area.

Photos 11 & 12: Isolated Stull and Lagging Support within Northern Drift near Junction of Main Adit Drift (looking inby with second stull visible in distance (left) and looking outby (right))

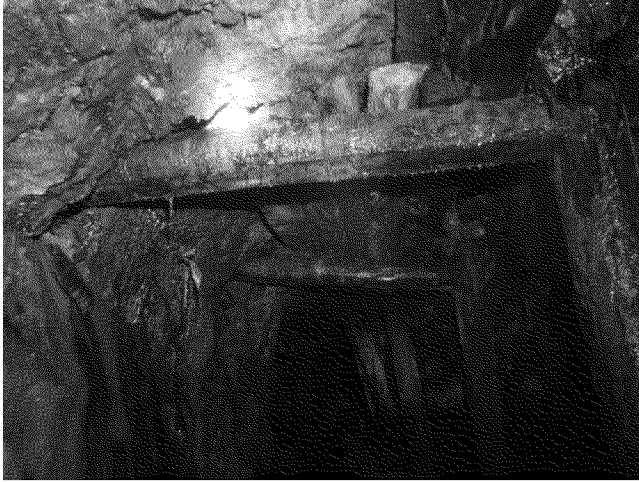
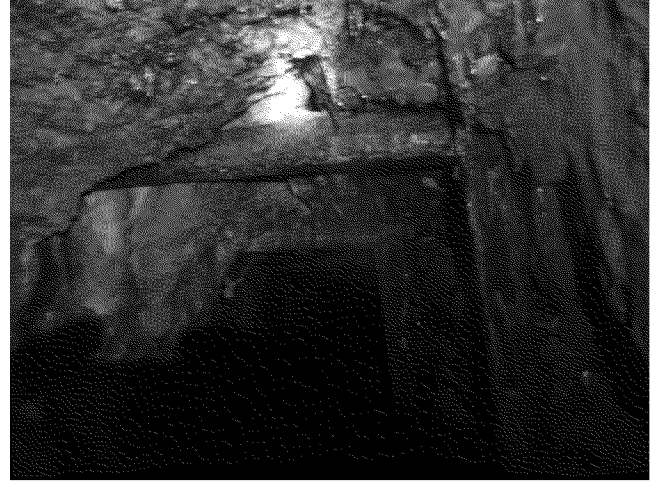
A more extensive timber lagged section exists further inby on the Northern Drift beyond an open stoped area where the adit appears to be following a mineralized vein. This area consists of a single post blocked to the rock followed by numerous sets of partial timber rib sets with overhead lagging and side lagging, timber stulls and lagging, followed by partial timber rib sets and crown lagging. The partial timber rib sets consists of a round timber post supporting a round horizontal beam which is keyed, wedged, or resting upon the inclined side wall; posts are on the left inby rib on the downstation end and on the right inby rib on the upstation end. Examination of the overhead conditions near the upstation end indicates a stoped area of approximately 6 feet above the timber lagging and approximately 1 vertical foot of rock debris loading the lagging. Similar to the other stulled section, probing with the point of the geologic hammer revealed that the interior of main timbers are solid with approximately 1/4" of penetration. The timber support system appears to be intact with no missing main members. The timber lagging overall appears to be in place with the most distressed lagging occurring in the sidewall on the downstation end of the supports. None of the main support members appeared stressed or overloaded and the overall system appears to be stable. The combination of the limited construction activities intended for the Northern Drift, the current stability of the timber system, and the limited rock loads acting on the timber system indicates that the probability failure during construction will be low. Although currently stable, it is recommended that a common sense approach be adopted during construction that avoids disturbing the existing timber supports and minimizes both the number of personnel and the duration that personnel will be below the timber supported areas.

**Photos 13 & 14: Partial Timber Rib Sets and Lagging in Northern Drift
(looking outby)**

The timber supported areas are located where construction activities will be limited and the timber supports do not appear to be heavily loaded and appear capable of maintaining the opening stability throughout the anticipated construction duration. As a precaution during construction, it is recommended that personnel avoid lingering below the timber supported areas or disturbing the existing timber members.

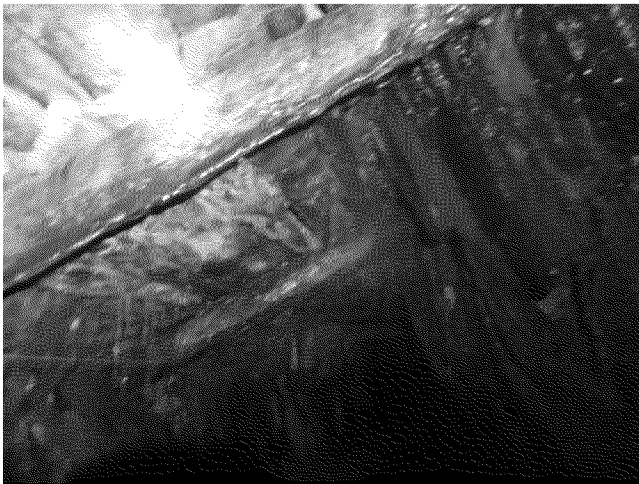
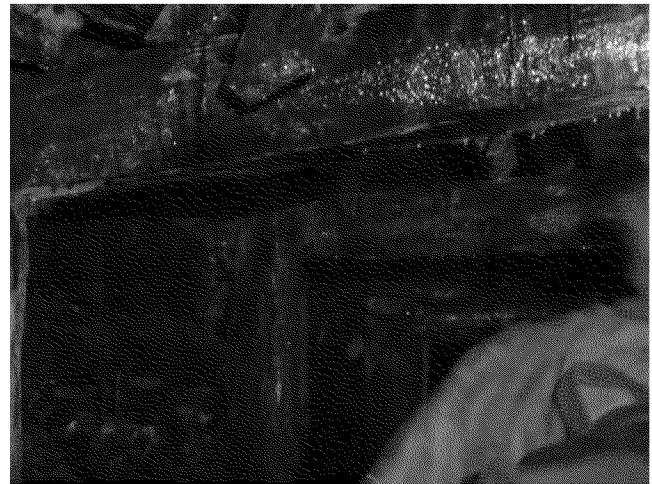
Photos 15 & 16: Stull and Lagging Support (left) and Partial Rib Supports (right) within Northern Drift
